# Storm Surge Case Studies

## **Abstract**

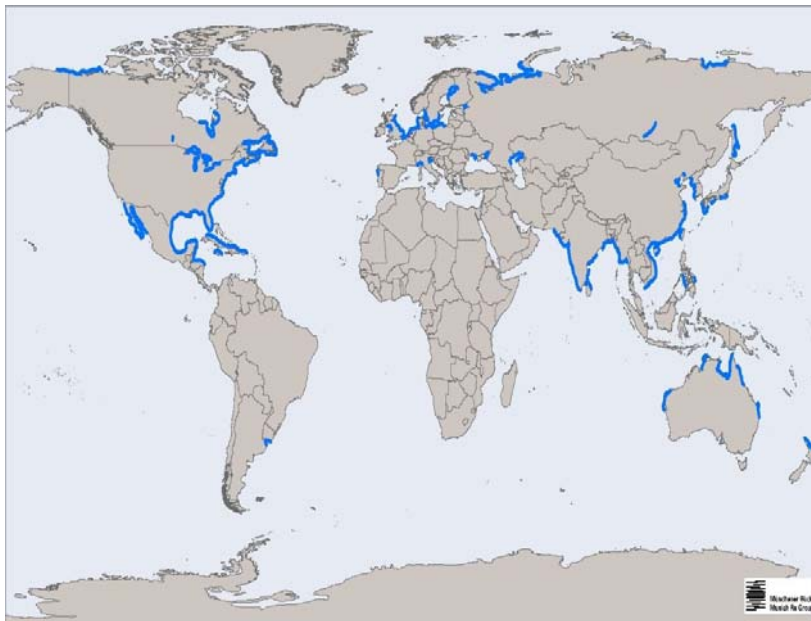
Figure 2: Coasts endangered by storm surges (with permission by Munich Re)

All coastal of the world where strong storms occasionally or regularly pass are affected by storm surges, which comprise most of the world's coasts (Figure 2). There are two major types of storms, tropical and extra-tropical storms. In principle there are more, such as polar lows, cold surges and medicanes, which regionally play a role with storm surges, but this chapter is limited to the two main types. The different characteristics of these storms and the associated surges are listed in Table 1.

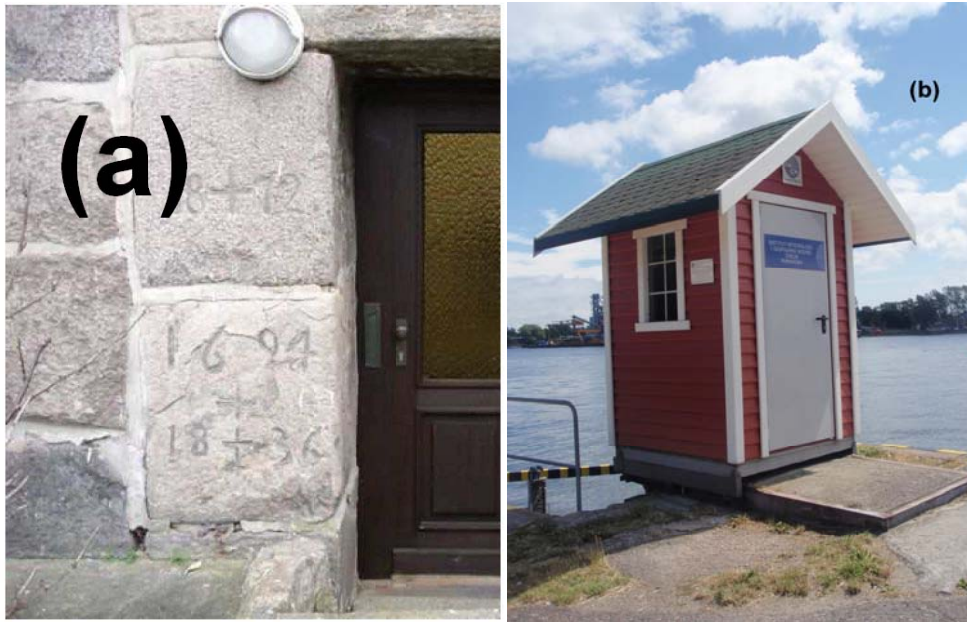
Figure 3: Recording storm surge heights – historical marks of high water (a) in 1872, 1694 and 1836 in Schleswig, Germany, and a modernized tide gauge in Swinoujście, Poland (b), which is with short interruptions operating since 1811.

A storm surge are a phenomenon that has always affected coastal inhabitants (e.g., Lu, 1984; Petzelberger, 2000). When assessing the intensity of historical storm surges, the simplest method determine the maximum water level is to measure markings on buildings (Figure 3a shows a marking at a house in Schleswig at the German Baltic Sea coast; Figure 3b shows a modern tide gauge station in Swinoujście, Poland). The measures for protecting people and property against these extreme and dangerous events have a long history, as explained by Niemeier, et al. (1996)

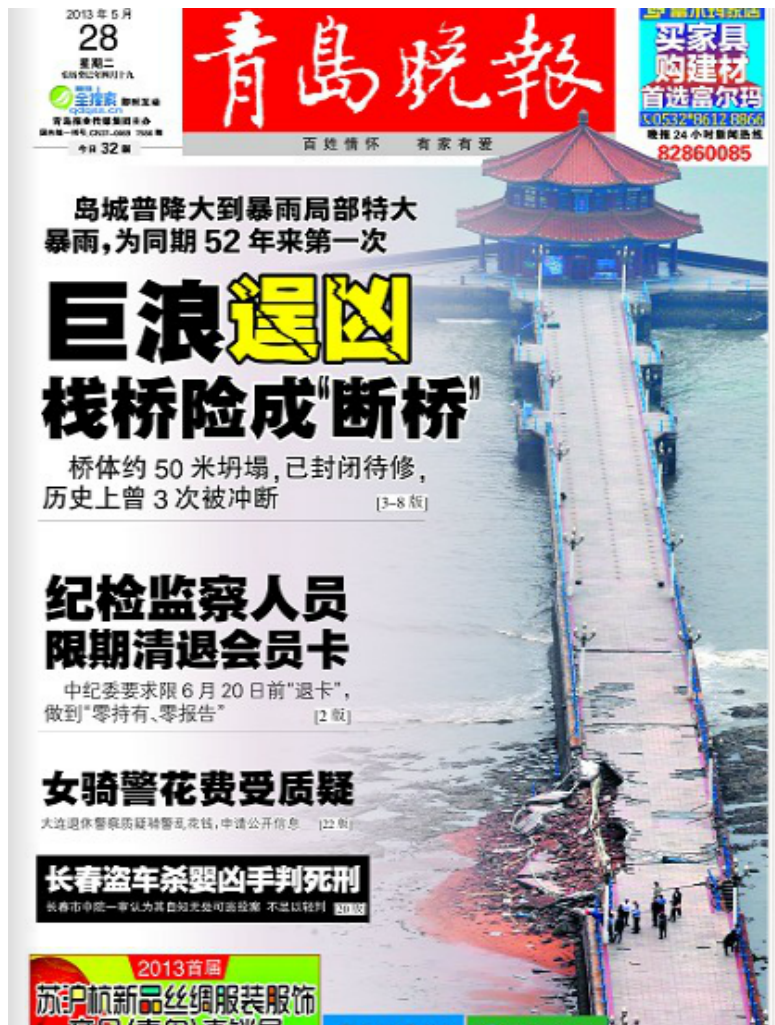
Figure 5: The local newspaper reporting the damage of the Zhanqiao Pier in Qingdao in 2013.

Along this coast, extratropical meteorological storms can also cause storm surges. In May 2013 a storm surge hit Qingdao. The famous Zhanqiao Pier was damaged for the fourth time in 100 years (Figure 5).

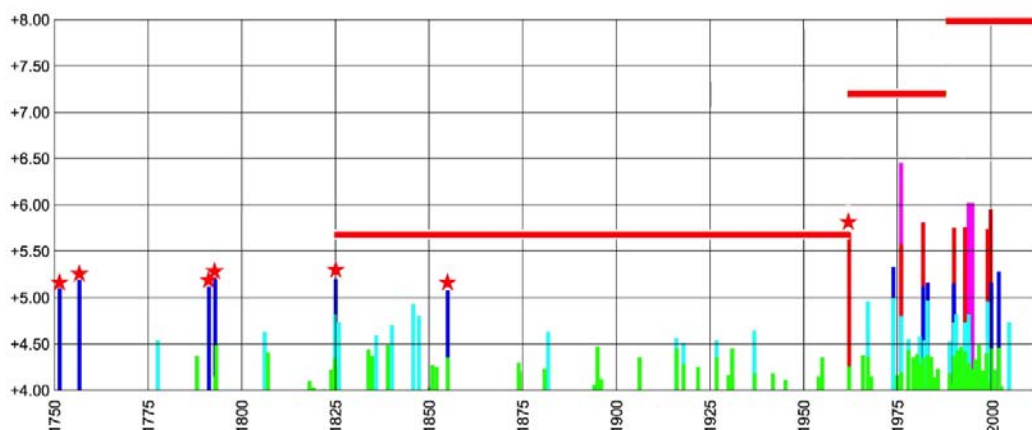
Figure 7: Storm surge heights (vertical bars) and dike heights (red horizontal lines) as recorded at the tide gauge St Pauli in Hamburg from 1750 to 2004. The color coding represents different surge heights. The red stars indicate dike failures. (von Storch et al., 2009)

In the 18<sup>th</sup> century, storm surges and breaking dikes were relative frequent in Hamburg. The dike failures took place at water levels of approximately +5.20m. Interestingly, these storm surges occurred in clusters. After the severe storm surge in 1825, dike heights were raised to +5,70m. After beginning to raise the dikes, and until 1962, only one severe storm surge happened (in 1855). After this storm flood, for more than 100 years until 1962, the improved dike levels were not really challenged; all gauge readings were well below +5.00 m.

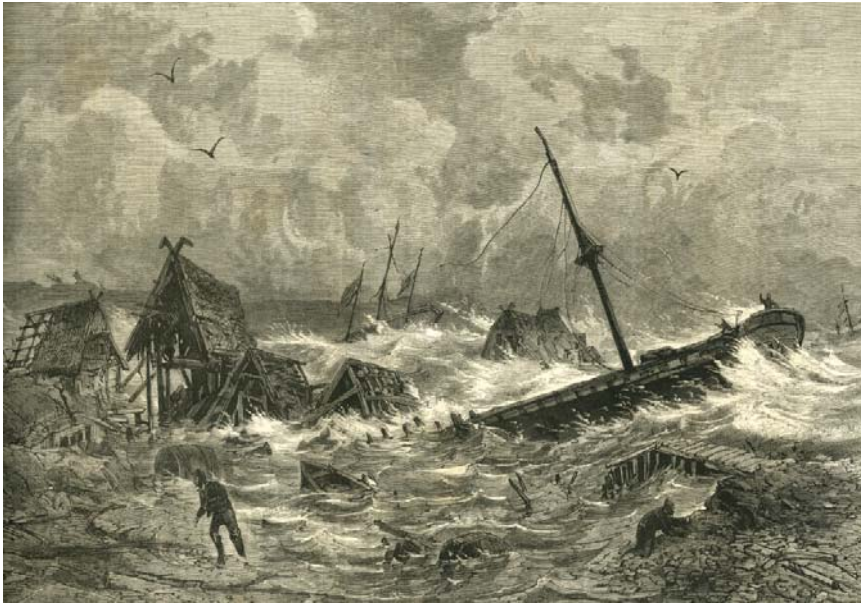
Figure 10: Southern Baltic Sea Storm surge on 13/14 November 1872, as depicted by *Illustrierte Zeitung*, Leipzig, 21.12.1872.

The greatest documented storm event in this region took place on 13-14 November 1872 (Figure 10). Many people lost their lives by the storm. Two years later in 1874 another great storm took place with high storm surges in Kołobrzeg (+2.20 m) and in Świnoujście (+1.96 m). Another strong event took place on 30-31 December 1904 at the Pomeranian Bay. Water levels near Rugia Island were about +2.5 m to +2.8 m, in Świnoujście +1.8 m, and in Warnemünde and Flensburg about +1.9 m to +2.2 m (Majewski et al., 1983). The highest water levels observed at the tide gauges located along the Polish part of the coast are presented in Table 2 (after Wiśniewski and Wolski, 2009).

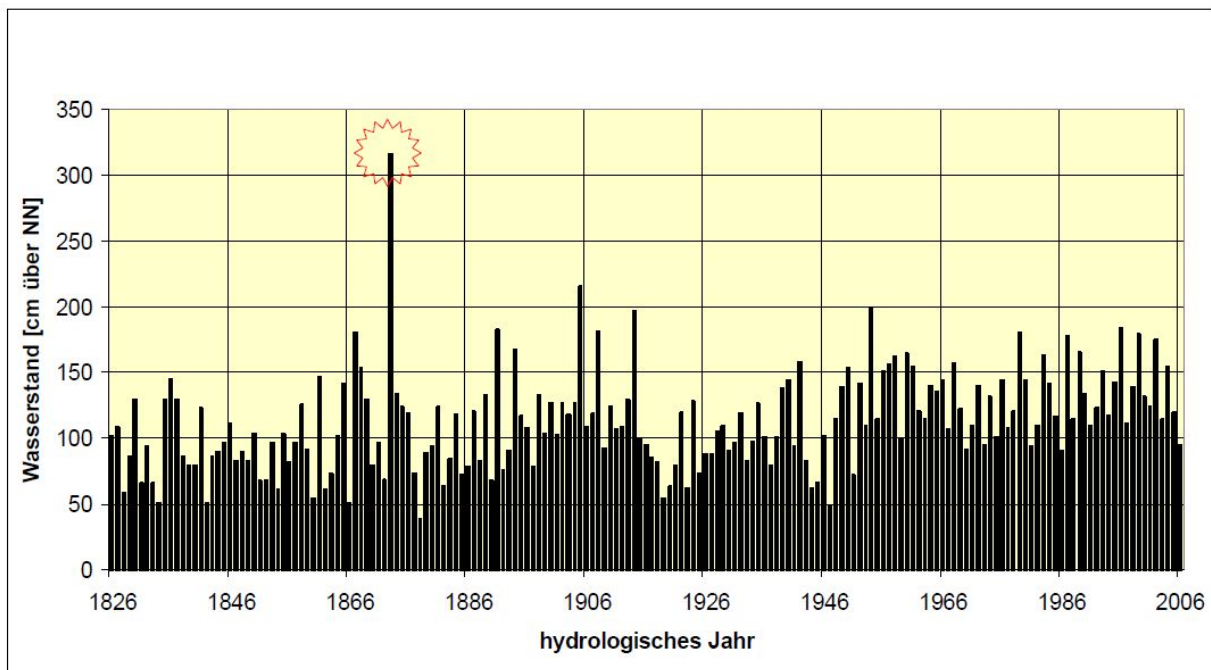
Figure 11: Annual maximum surge heights in the years 1826-2006 in Travemünde, Germany. Notice the peak for 1872. From Rosenhagen and Bork (2009)

The storm event on 13-14 November 1872 was successfully reconstructed from pressure maps and surge heights, scattered air pressure data, and numerical modeling by Rosenhagen and Bork (2009). The intensity of 1872 event is put into perspective when plotting annual maximum storm surges from 1926 to 2006 (Figure 11). The maximum surge height in 1872 was about +3.30 m, while in all other years the level of +2 m was almost never passed. Indeed the 1872 event was an outlier. If it had not been documented so well at multiple locations, one may be misled to suspect the recoding as an error. It is suggested that this event was due to the concurrent effect of a basin-filling, the wind-induced surge and a contribution of the major eigen-oscillation in the Baltic Sea.

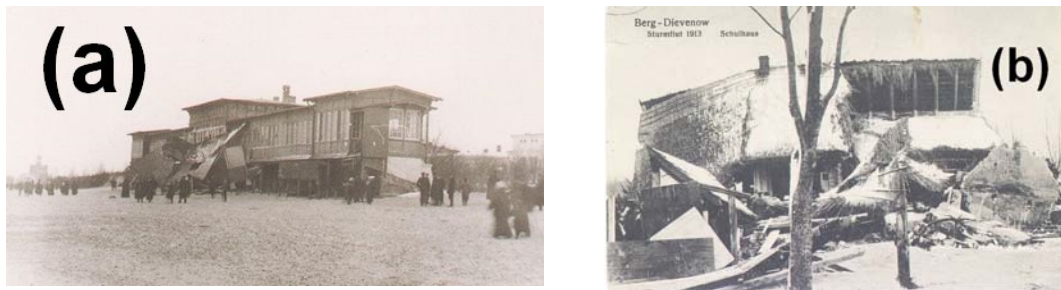
Figure 13. Postcards showing damages in in Dziwnów, Poland, caused by the storm surge on 30 December 1913.

(a): Beach hall; (b): Schoolhouse

Unfortunately, on 30 December 1913, a substantial storm devastated the “Pearl of the Baltic” and the community has not since been rebuilt. The devastation started on 27 December with strong N-NW winds (Beaufort 8-9). On 30 December the winds shifted to N-NE and formed a strong storm surge. Elevated water levels in the region were observed, for example: Kołobrzeg (+1.59 m), Świnoujście (+1.98 m), Travemünde (+1.95 m) and Kiel (+1.82 m) (Majewski et al., 1983). In the afternoon of 30 December water overflowed the low dunes and flooded the low-lying hinterland. Part of the town was affected and several buildings and tourist infrastructure were partly destroyed or filled with water (Figure 13).
